# **Technical Newsletter**

#tnl2024-0017e # 1 / 2

# Notification of Software Release for Safety Measures when Opening the FLANGE DRESSING Screen

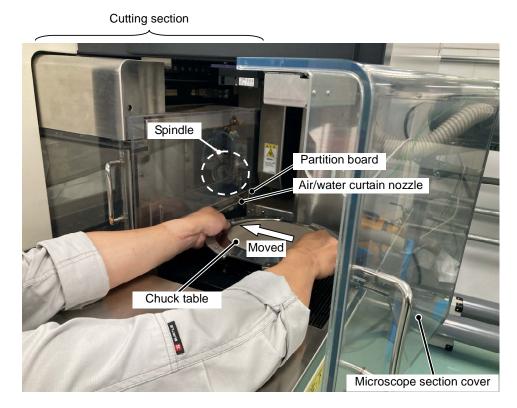
On DAD3350, an operator selected the wrong operation buttons when trying to remove the chuck table. When they opened the microscope section cover and held the chuck table, the hand that was holding the chuck table got caught between the chuck table and the partition board and air/water curtain nozzle when the chuck table tried to move below the spindle, causing an accident that left a slight bruise on the back of their left hand.

The operator intended to press the <F6: Machine Maintenance> button and then the <F1: C/T Removal> button to remove the chuck table for maintenance purposes. However, the operator accidentally pressed the <F7: Engineering Maintenance> button and then the <F1: Conditioning> button.

In the standard specification equipment, an engineering password (upper level password set by the customer) needs to be input when the <F7: Engineering Maintenance> button is pressed. However, this equipment had a user-specified specification that separates the accessible screens depending on the operator. In addition, this operator had the access rights to open the screen for flange dressing without entering the engineering password.

In the specification of the applicable models, when the <F1: Conditioning> button is pressed on the ENGINEERING MAINTENANCE screen [7.0], the equipment confirms that there is no workpiece on the chuck table after confirming that the microscope section cover is closed, and then the X-axis movement is executed. However, if the microscope section cover is opened while the equipment is checking for the presence of a workpiece, the X-axis starts moving even if the microscope section cover open.

In the specification of the applicable models, the X-axis automatically stops if the X-axis moves away from its origin point. However, the X-axis may move toward the cutting section as there is a time lag before the automatic stop (the movement distance differs depending on the model).

In order to prevent the accident from reoccurring, we will release a countermeasure software that initiates the X-axis movement after checking that there is no workpiece on the chuck table in addition to confirming that the microscope section cover is closed when the screen for conditioning operation is opened.

The countermeasure software is embedded in the patch software (part no. PAKBM15V152U) of version 1.52.
